GOLDEN FORENSICS

SUMMARY OF FINDINGS

INSURED: Asplundh Tree Service

LOSS LOCATION: 197 Louis L'Amour Lane
Clark, Wyoming

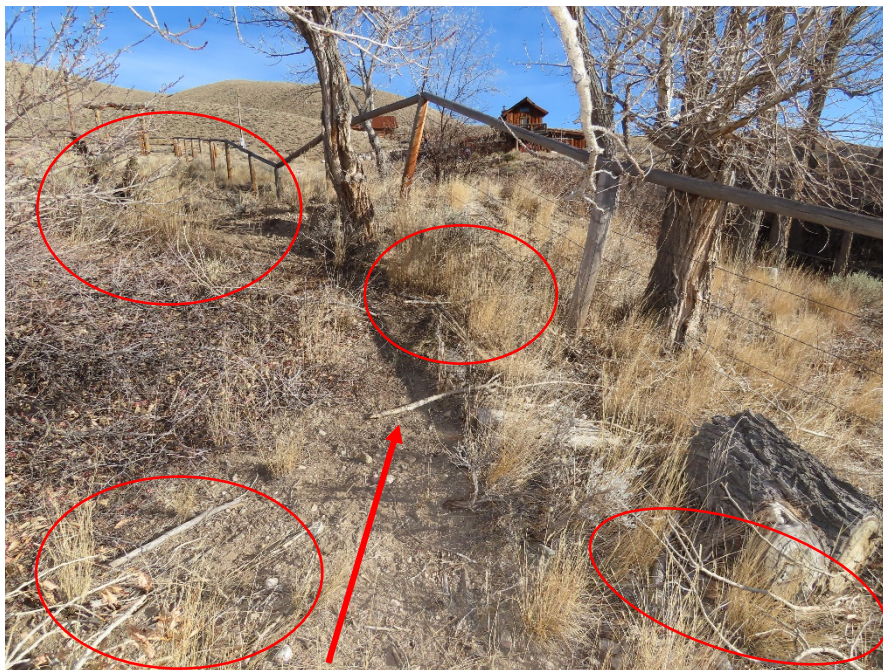
A photo I, INV F Schmitt, took on November 22 shows numerous cottonwood branches within inches and feet of E-1, contrary to Carlson's statement. It further shows Branch E-1 had been moved between Pam Nelson's photo 0017 from November 16, 2023, which Carlson stated he reviewed, and my photo on November 22, 2021.

There was no indication that the branch was involved in the November 15, Clark Wildfire. The branch may have been there a week, a month, or months prior. It may have been charred due to youth campers using it to stir a campfire? There is no physical evidence to show it was involved with the Clark Wildfire and therefore considered but ruled out as evidence to the event.

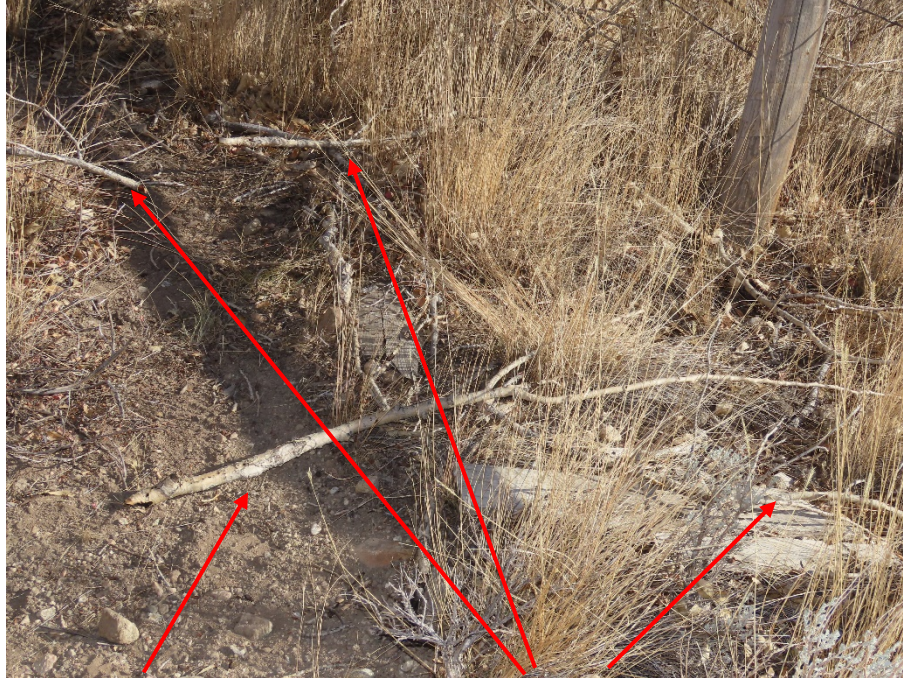
E-1

Other Cottonwood branches

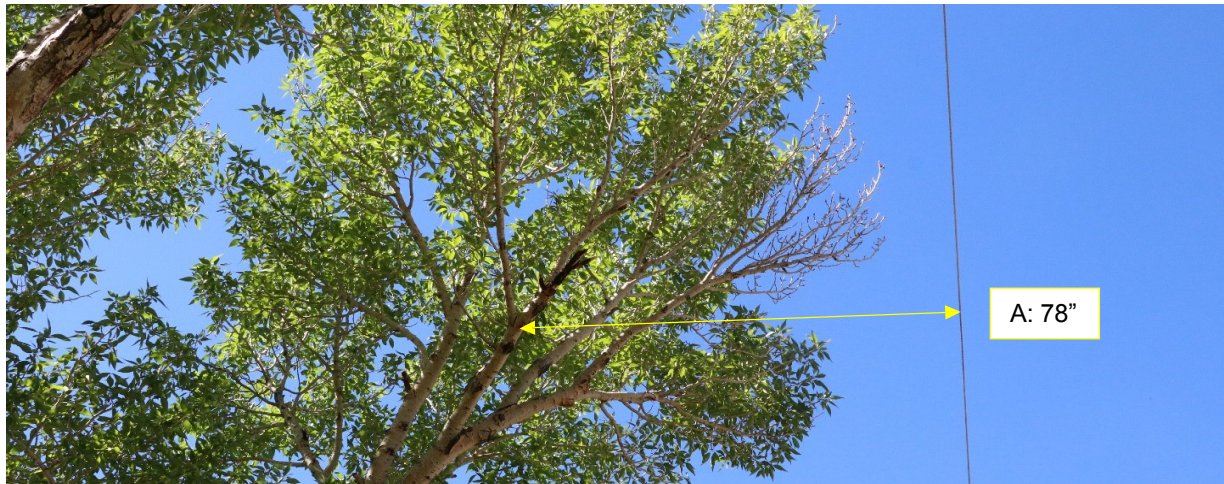
Paul Way Figure 8

As shown in Paul Way's photo, the tip of E-11 was not oriented toward the exterior of the crown where the wind could easily manipulate it, it was located on a heavy branch more closely oriented toward the trunk of the subject cottonwood.

Item 2 from above: Based on charring found on E-11 still attached to the cottonwood tree, it is possible a tree line contact occurred at some point in time. According to Paul Way, EE.P.E. the charred end of E-11 measured six feet, six inches from the east phase.¹⁰ During the June 16, 2021, joint evidence collection, Jensen Hughes Engineers measured the distance the de-energized conductor could be manually pushed to the east in the direction of the tree. The maximum distance the line could be pushed to the east was four feet. Two feet, six inches short of contacting the end of E-11. Even though Paul Way attempted to connect the two items, east phase and E-11 end, to demonstrate a tree line contact, they were unable to do so by thirty inches.

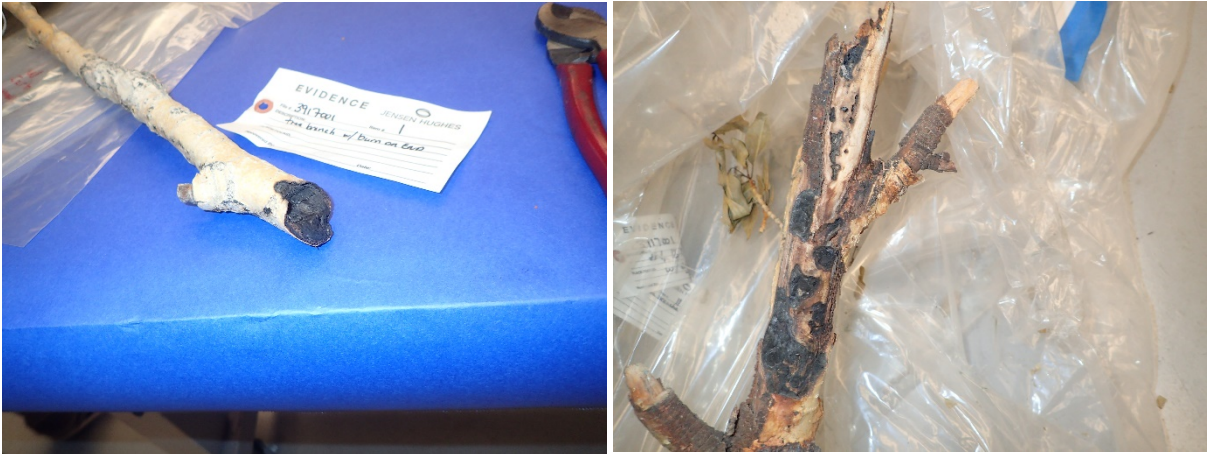
The charred end of E-1 was 1.092 inches per a micrometer¹¹ and had exterior bark fully surrounding the round char end. The charred end of E-11 had a jagged torn end that did not match the end of E-1. The bark on E-1 and E-11 were significantly different as shown in the photo below.

Round charred end of E-1 doesn't match torn charred end of E-11, bark does not match either. K Schmitt IMG P6120079 and P610074

Despite these obvious differences, Investigators Carlson and Way opine these are the same branch, making no effort to explain the different bark patterns, or the difference in the charred ends. This is confirmation bias. Forensic Arborist Mike Neal stated in the June 16, 2023 lab exam, E-1 and E-11 are not from the same branch and probably not from the same tree.

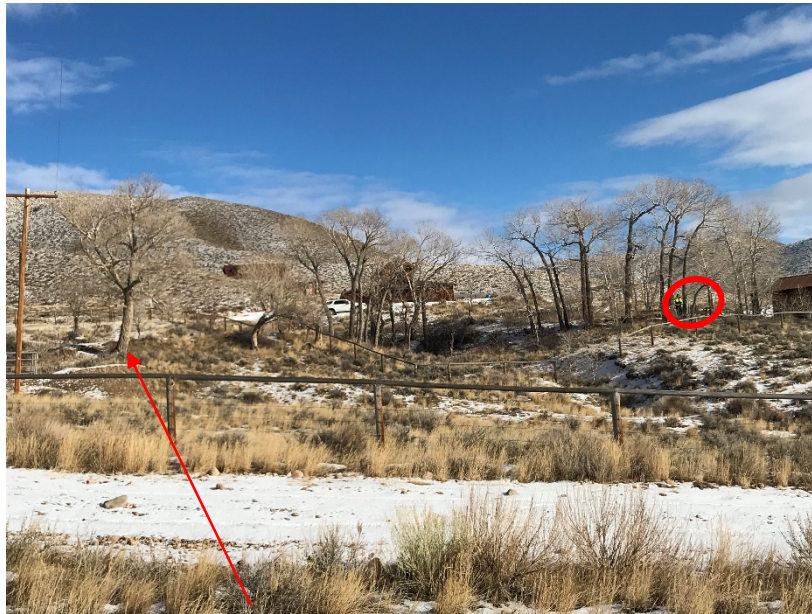
Clark VFD IMG 1220 - Terrain and unburned fuels between subject tree and origin. Note the uphill slope just below the origin.

The area between the east phase, and the specific origin area 147 feet east was densely covered with cured grasses, leaf litter, small twigs, and brush. Not a single spot fire, not a single area of charring was found between the subject cottonwood and the specific origin 147 feet down wind during my November 22 scene investigation.

The Clark VFD fire report¹³ also states the first spot fire was 139 feet from the west side of the subject cottonwood with no spots in the dried grasses in between these two areas. Clark VFD photo LL4/ Clark Fire 000011 shows unburned cured vegetation between the cottonwood and

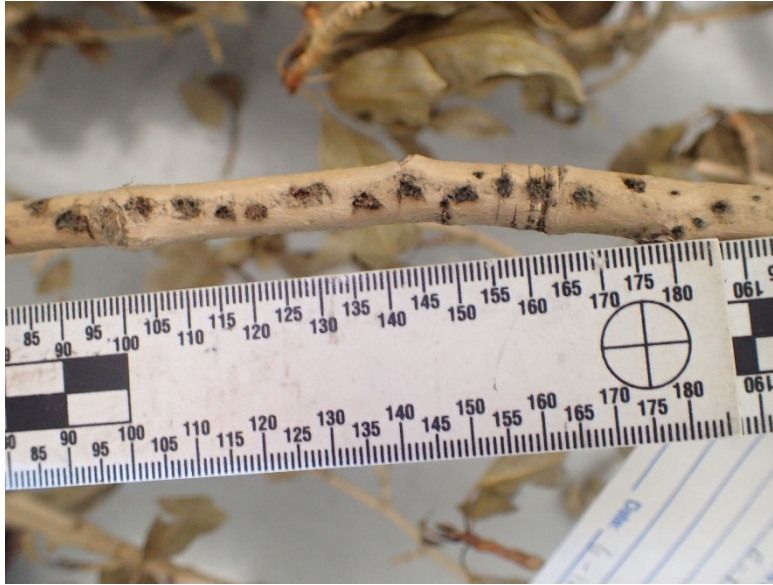
Schmitt IMG P6120014, June 12 lab exam Micron Imaging

Arc Tracking¹⁴. Evidence items E-1, E-9, and E-11 all have varying degrees of small, pin hole, marks that ran longitudinally on the outer skin of the bark. The marks were several mm apart and formed a pattern similar to arc tracking.

Upon seeing these patterns, I also initially thought these marks may have been the result of electrical arc tracking on the branches. Arc tracking, also referred to as arcing through char, occurs when an electrical current follows a path of least resistance, usually involving moisture or a conductive contaminate on the surface of the subject item such as salts, conductive dusts, and/or liquids. Small leakage currents creating a path of carbonization, carbon being conductive allows the current to continue flowing along the carbonized path leaving a narrow trail or path of charred surface.

The marks on items E-1, E-9, and E-11 could not have been caused by arc tracking as any possible contact with the east phase would have been intermittent, and not sustained. Further, any possible tree line contact would have been random, and not at a specific contact point on the branch.

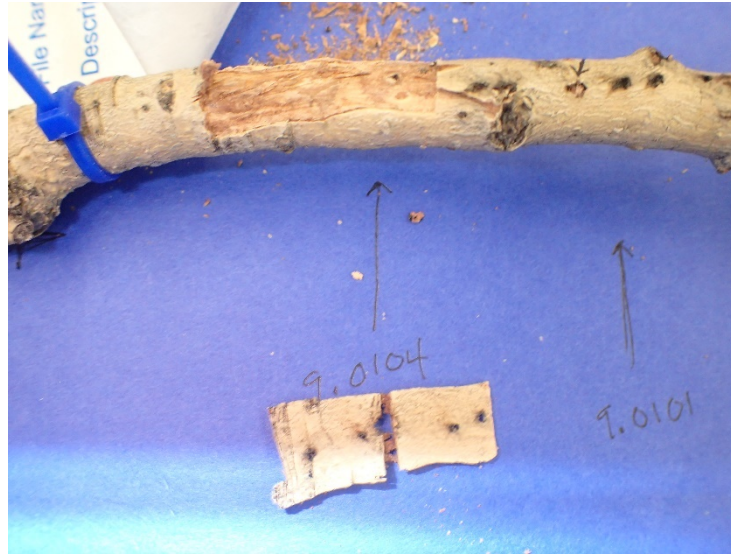
Schmitt IMG P6120044. June 12, 2023, Lab Exam. Micron Imaging

During the lab exam, forensic Tree Pathologist Ana Fulladolsa Palma, Ph.D. working for the plaintiffs, sliced a thin section of bark from under the pattern. No current path or arc tracking was found.

The marks suspected of being arc tracking were not from electrical current contacting the branches but were biological. Paul Way, EE, P.E. was present for this evidence examination.

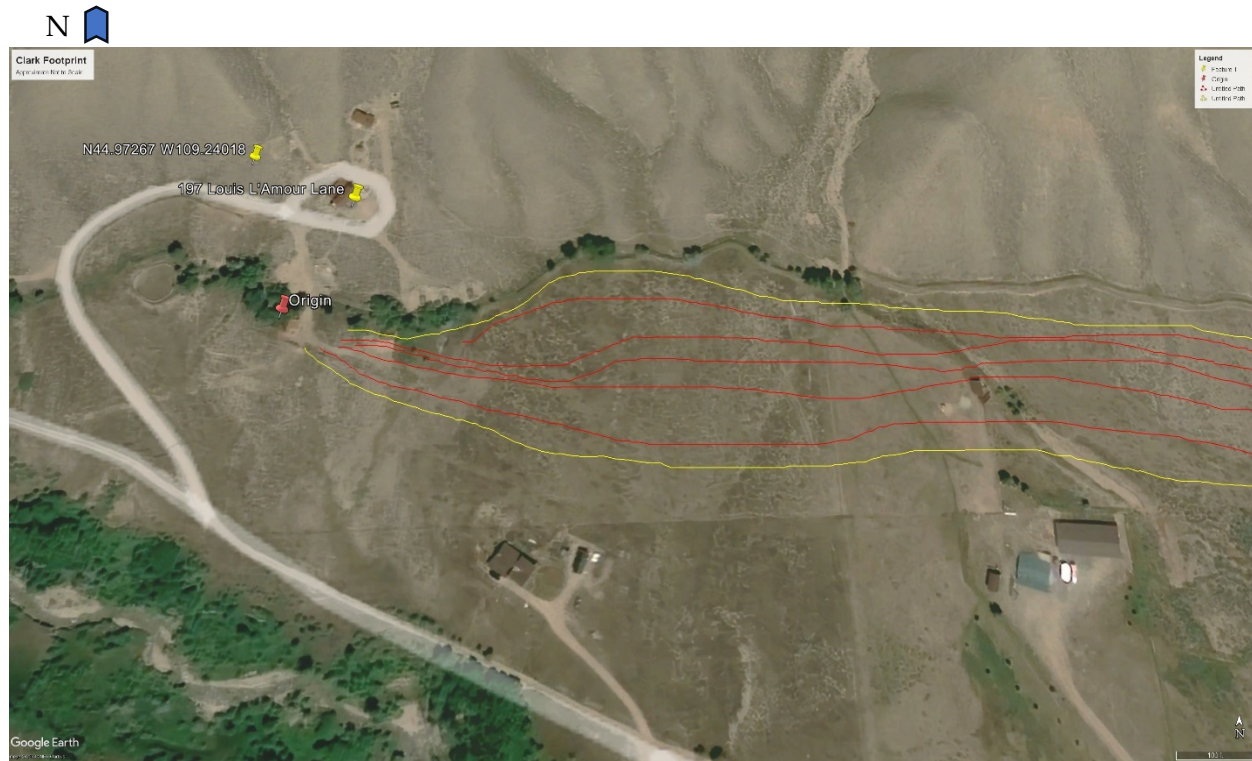
Approximate spread left, (West) to right, (East). Not to scale Flanks-Yellow, Advancing-Red

The Clark Wildfire was a wind driven event, with a very narrow “V”, and little or no backing fire. This was documented by the Clark VFD and is consistent with the reported opinions of the various origin and cause investigators involved with this fire investigation.

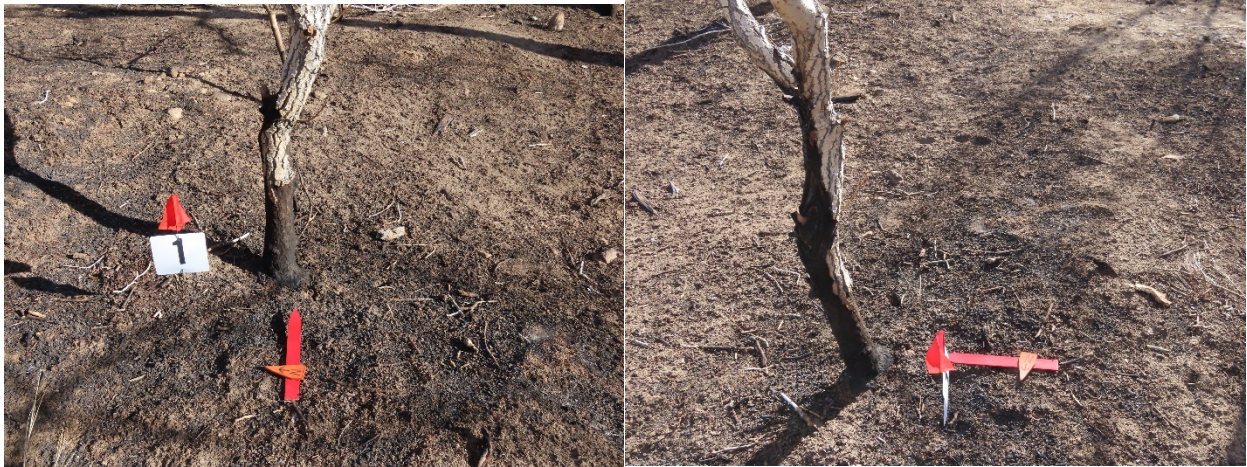
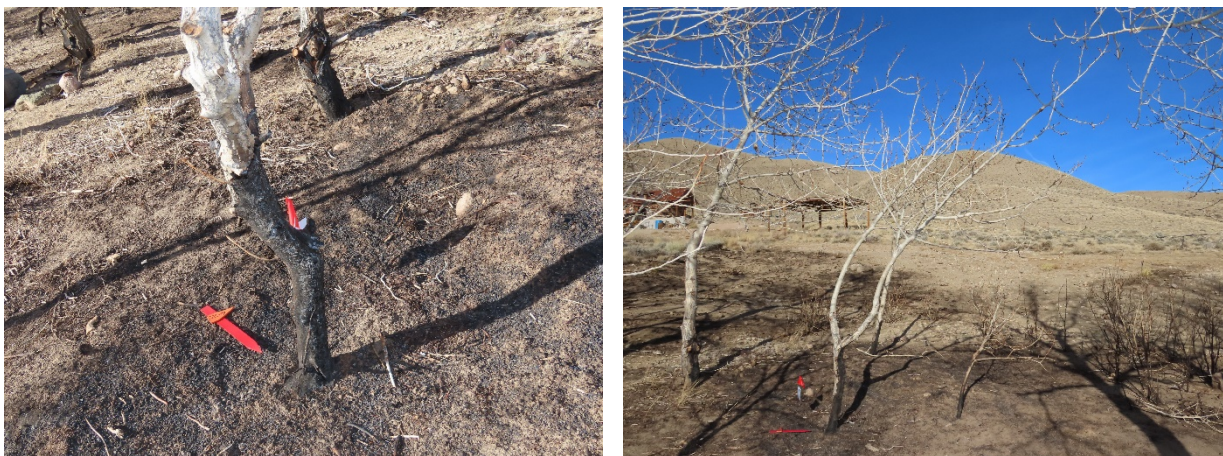
FPI 1

In these photos, the red arrow points toward the direction the fire is traveling, the small orange arrow points toward north to orient the FPI in the photo, and the number placard assigns a

number to each FPI for documentation. The pattern for FPI #1 would be angle of char, with vortex wrap on the back side of the tree indicating a high wind.
